MINE SITE VISIT REPORT
New Mexico AML Program

Date of Visit : August 30, 2007 **Weather :** Sunny 85°
Mine/Project Name: Barbara J # 3 Mine – Northwest of Grants, New Mexico
Duration of Visit : 1.25 hour (12:45 pm to 2:00 pm)
Purpose of Visit : Maintenance inspection to the Barbara J # 3 mine, main shaft, part of the legacy site assessment for AML project sites.
Observations : Travel to the project site; access to this site was from the west using a two track road. Location: NE1/4, NW1/4, NE/4 of Section 30 T.13N., R.9W., Dos Lomas Quad. UTM Zone 13, E243110 N3913420; Uranium Mine. This site is on BLM land.

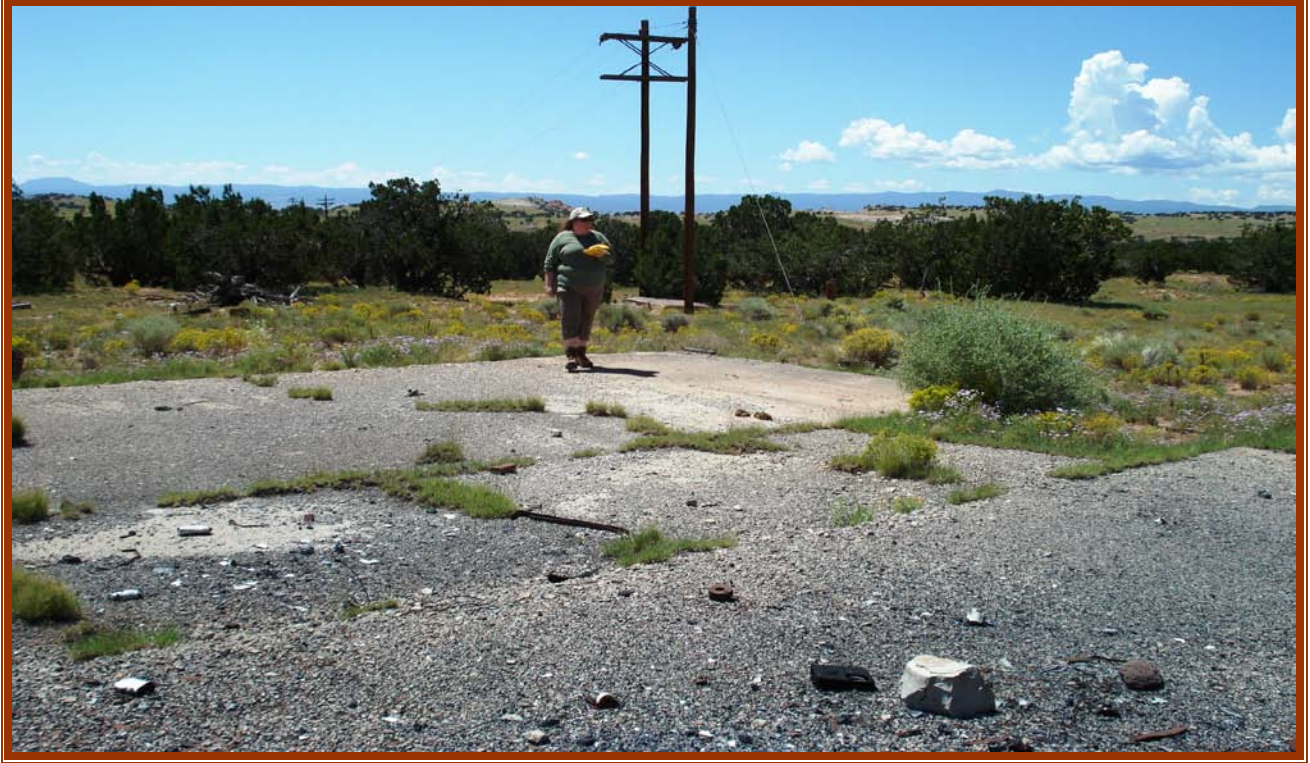
Concrete Foundations Looking South

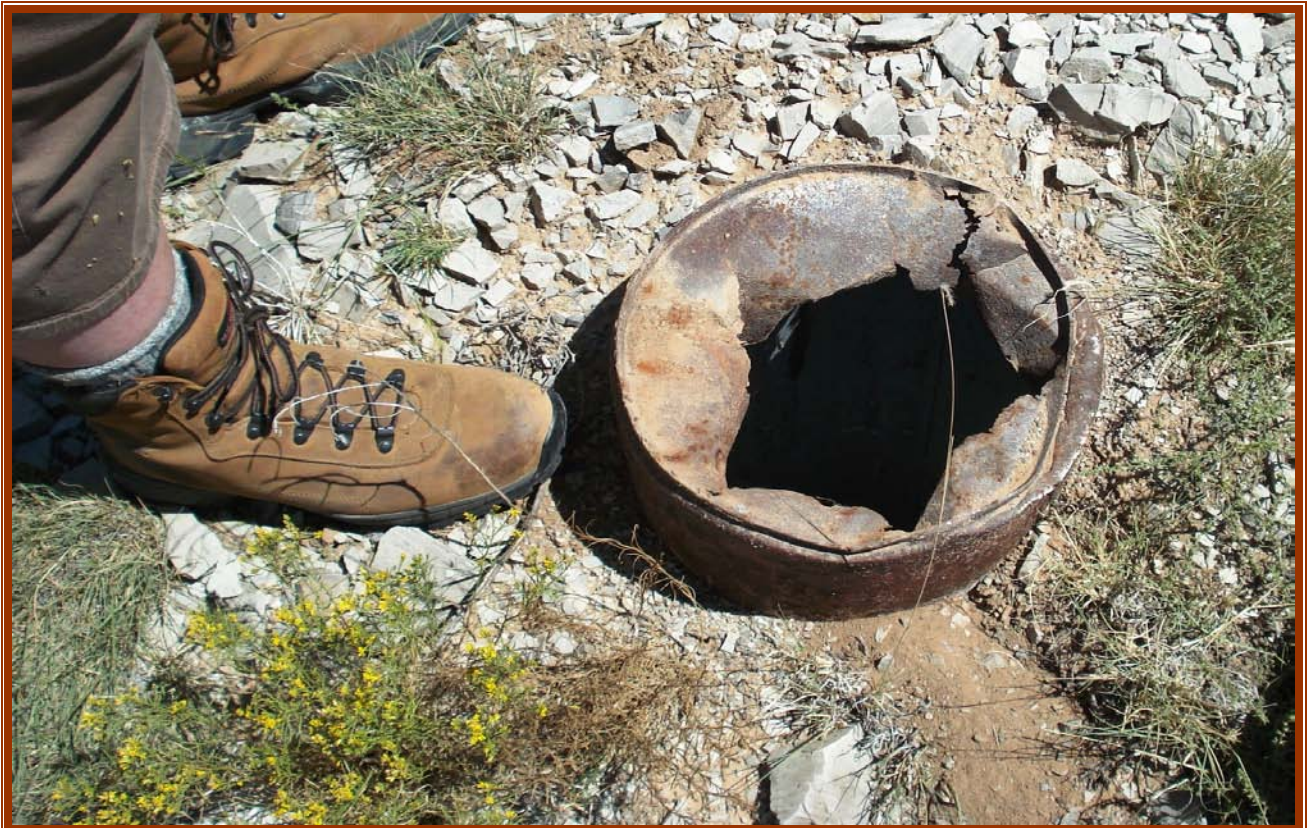
Metal Lined Vent Shaft With Rock Cover Removed Looking Down

Further action recommended to mitigate radiometric levels. Several drill holes and a vent shaft need to be closed.

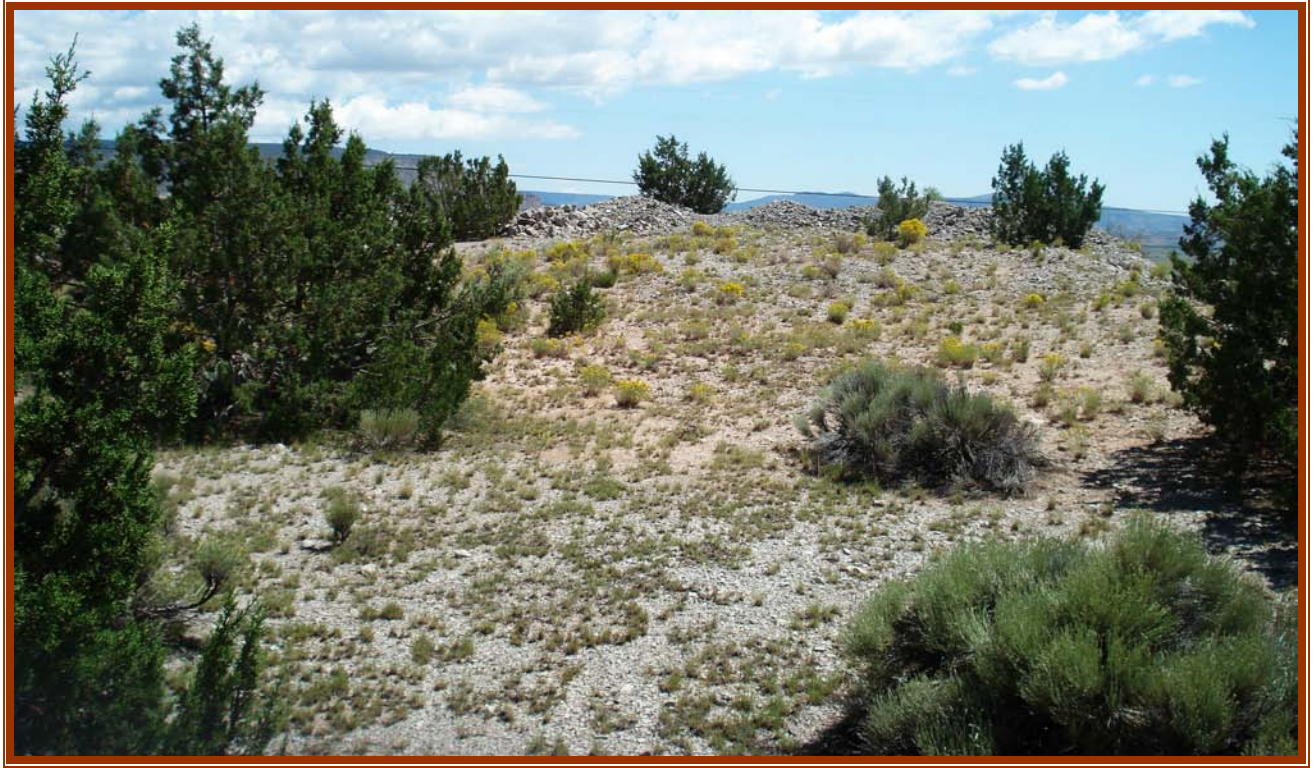
Top of Large Waste Pile Looking East

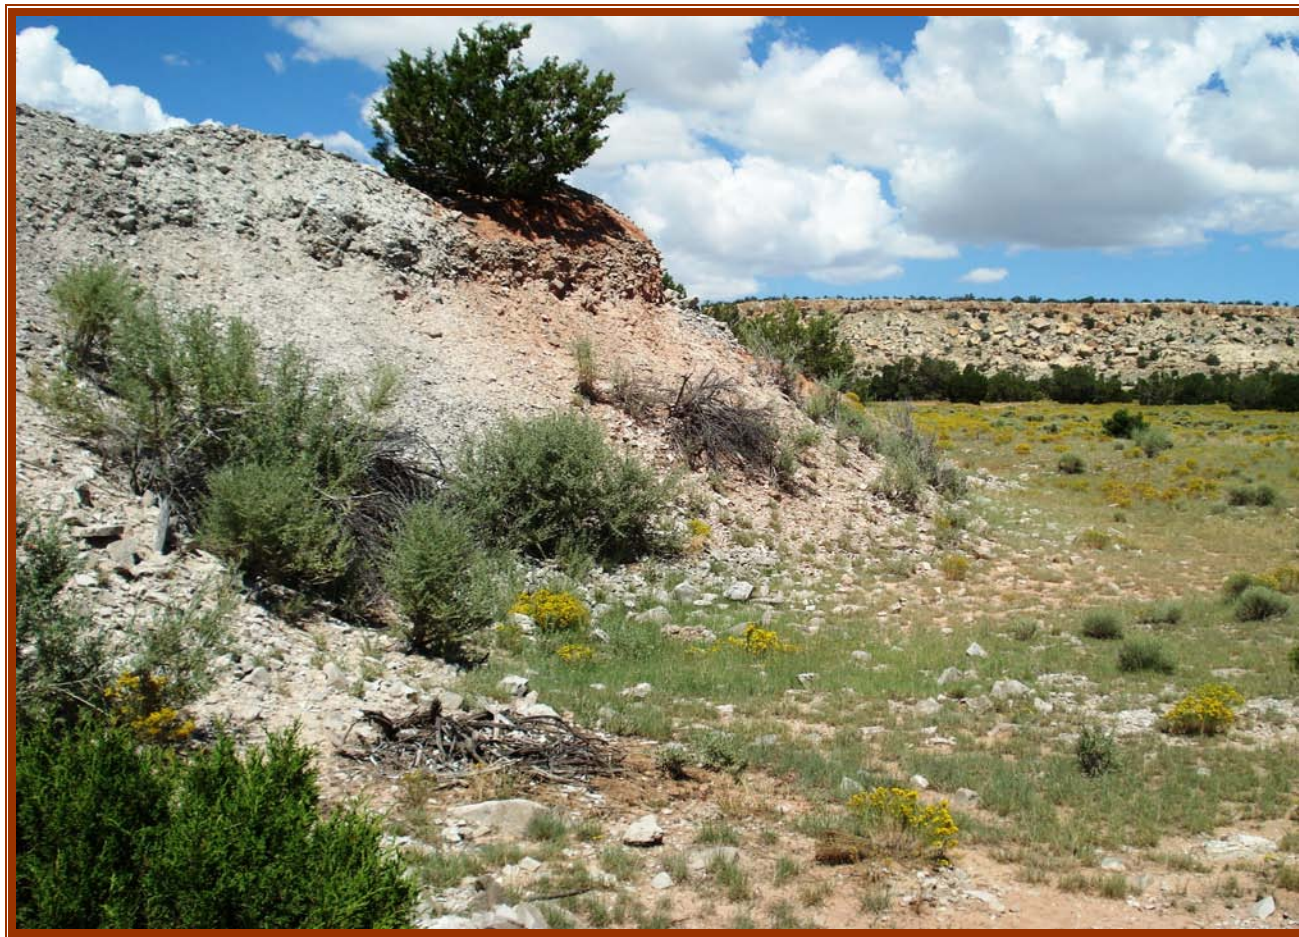
Bottom of Large Waste Pile Looking North
